Manhole Inspection Summary

Manhole # S31GG_073MH

Insp Date: **1/18/07 10:06 AM**

Location Address: **1321 PARK AVE**

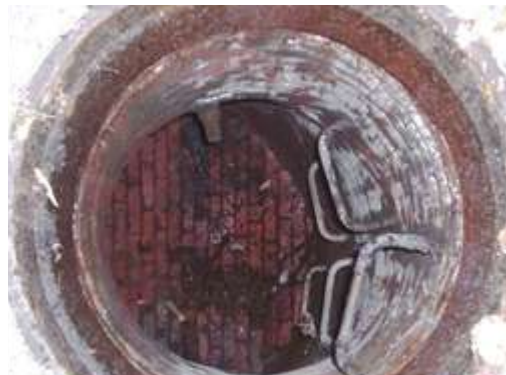
Top View

Channel Material: **Brick** ☐ Parged ☒ **Debris** (not Condition related)

Channel debris.

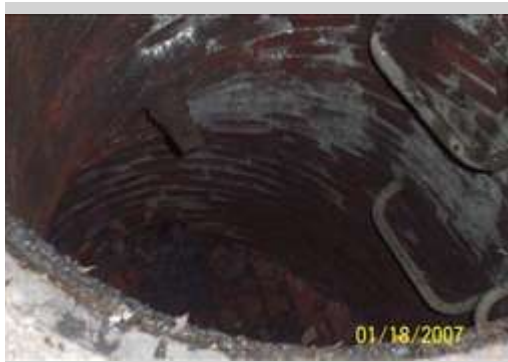
Defect

Faucet or unknown pipe coming into the MH.

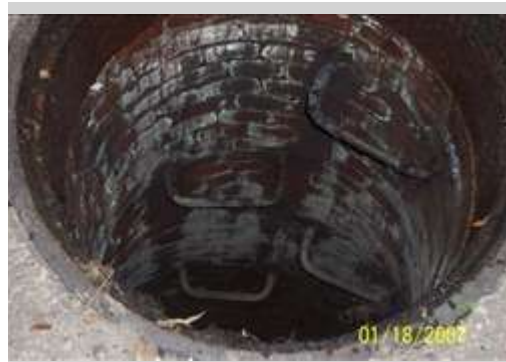
Defect

Frame Offset: **0** (in.) Condition: ☐ Sound ☐ Cracked ☒ **Leaks**

Infiltration: ☐ None ☒ **Joint** ☐ Cracks ☐ Mortar ☐ Roots ☒ **Wall**

Infiltration: ☐ None ☐ Joint ☐ Cracks ☒ **Mortar** ☐ Roots ☒ **Wall**

Frame leaks. Adjustment, Corbel and Barrel infiltration.

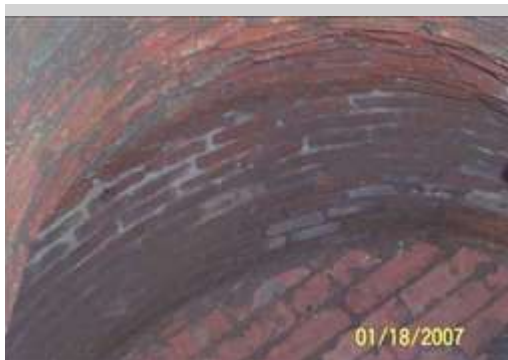
Defect

Barrel infiltration.

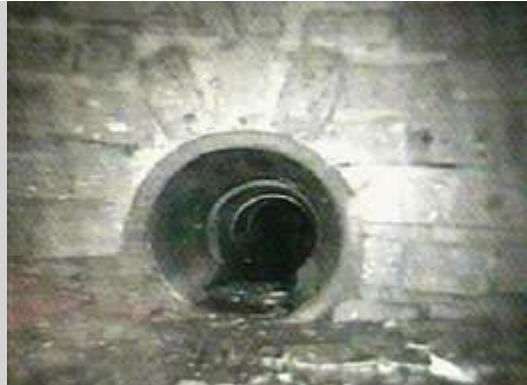
8 in. Circular Gravity Sewer
Pipe Out @ 12 O'Clock

Deposits: ☐ None ☒ **Mud** ☐ Sludge ☒ **Debris** ☐ Grease

Silt Depth: **0.5** (in.) Deposits Extent: **Light**

Infiltration: **Evidence** Pipe Seal Cond: **Unknown**
